AVIA PROPELLER Ltd.

INFORMATION BULLETIN

No.: V 503/2

Refers to: Removal of the leakage of airscrew V 503.

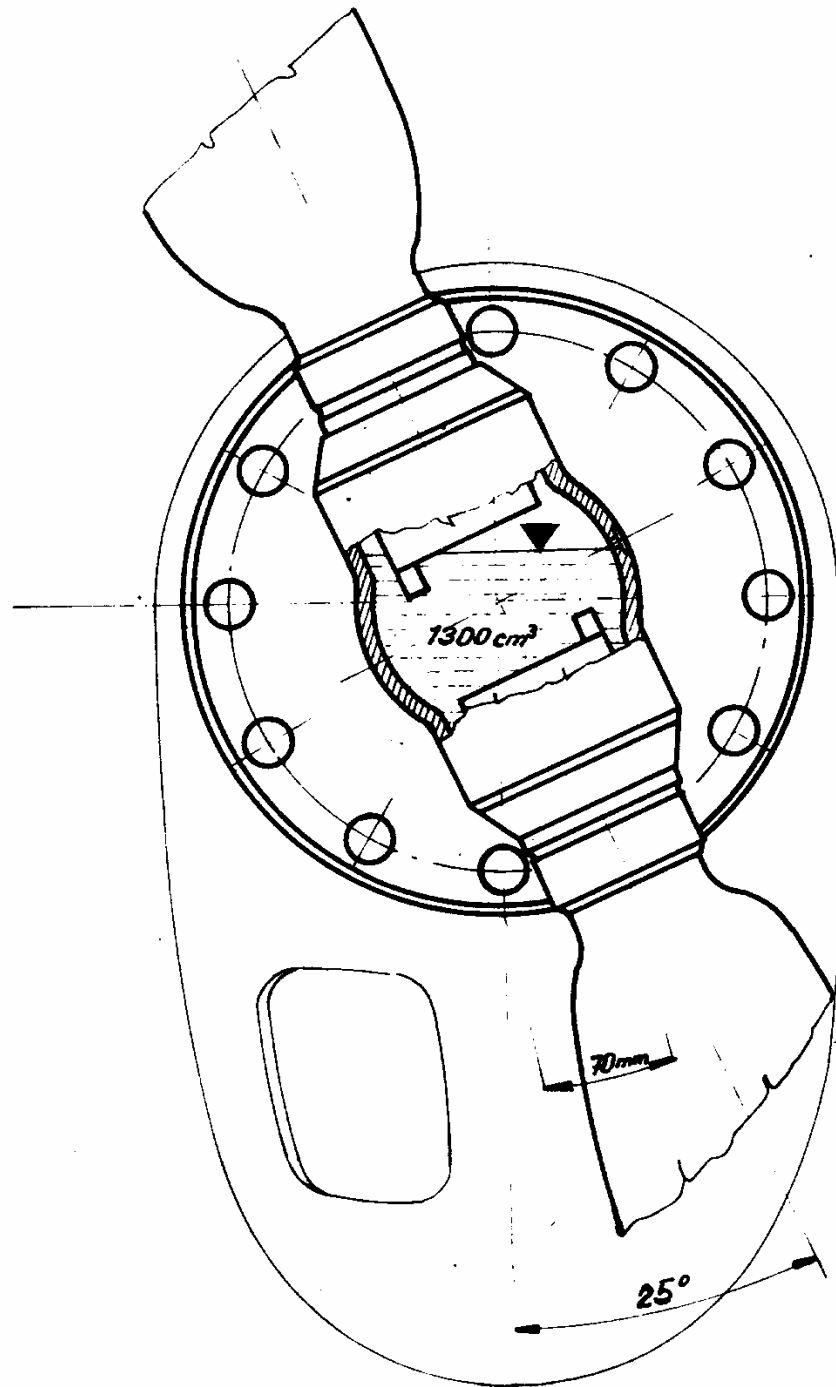
4. When ascertaining the causes of the leakage, it was found, that the oil diffusion arises only when the engine is at rest by spontaneous oil leakage into the airscrew fan, which, during the flight, causes spattering of oil on the airscrew and/or on the aircraft.

- a) by compression of the airscrew fan - shaft with the engine at rest, when oil is plainly forced out of the airscrew. To this fact attention has been drawn already in the service instructions, paragraph f/ - Assembly of the airscrew fan.

b) by uncorrect (vertical) position of the airscrew with the engine et rest, at which the compensation of the oil filling level in the airscrew hub is prevented. In a case, that the airscrew does not remain in horizontal position after the stopping of engine it is necessary to check whether the axis of any airscrew blade is pointing to the mark "0" on the flange (see Fig. 10 of the Technical description). If the assembly of the airscrew on the flange has been carried out correctly, it is necessary to dismantle the airscrew and to check whether the key of the shaft fits in the slot of the flange marked by "6".

1. Replace the silon packing ring V 503-3003 (pos. 53, Fig. No. 1 in the Technical description of the airscrew V 503) with a new ring, which the user will receive on request by return from the manufacturing plant.

2. Check the quantity of the oil filling in the airscrew hub. In order to carry out this check correctly, it is necessary to set the airscrew in such position, in which the blade axis will include the angle of 25° in relation to the vertical axis of the engine. This position can be set easily with the help of the arch distance between these two axis, which is 70 mm on the circumference of the rear part of the air screw housing (see the Figure on the following page). For detailed description of the check see the Technical description and service instructions of the airscrew V 503; please correct the stated position of about 45° to 25°.

3. In the case, that the leakage will not be removed even after these modifications, it is admissible to reduce the quantity of oil filling in the airscrew by 100 up to 200 ccm.
