AVIA PROPELLER Ltd.

INFORMATION BULLETIN

No.: V 506-8-I/68

Concerns: Flooding of V 506 prop servomechanism in flight operation in the USSR.

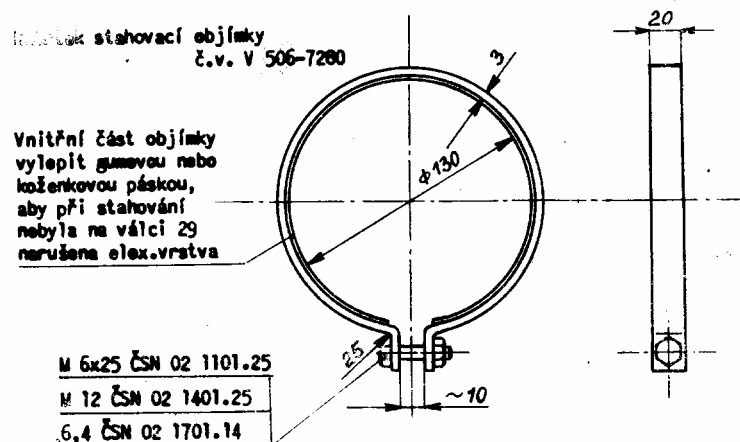
Reason: Downgrade of V 506 prop function as owing to setting of carbon sediments from engine lube oil.

- 2) Take off the Seal and disengage Lock Bolt (Ref. 27 on Fig. 2). Put Wrench No. 1. into cut in Bolt of Cylinder (Ref. 26). Thread on this wrench on backstop tightening sleeve P/N V 506-7280 and tighten it well. Dismantle the Outer Ring (Ref. 29) with Tube (Ref. 2) which together forges compact assembly by the loosening of Bolt of Cylinder (Ref. 26).

- 4) Carry out backward prop assembly after this prop and servomechanism cleaning. Clean up parts and rubber packing and put on Outer Cylinder (Ref. 29) into prop on Pin (Ref. 28), that is identified position of servomechanism. Put on Bolt (Ref. 26) and tighten by torque moment 20-25 kgm and lock it by Bolt (Ref. 27). Surplus assembly of prop carry out according to "Technical Description and Service Instruction of V 506 Propeller", see chapter "Prop Assembly".
- 5) Inscribe servomechanism and prop cleaning in Propeller Log Book.
