AVIA PROPELLER Ltd.

MADATORY BULLETIN

Number: V 500A/ 6a

Refers to: Oil distributor flange on the V 500A propeller, distributor drawing No. P 7900-6111. The propeller is installed on the Z 142 and Z 43 aircrafts.

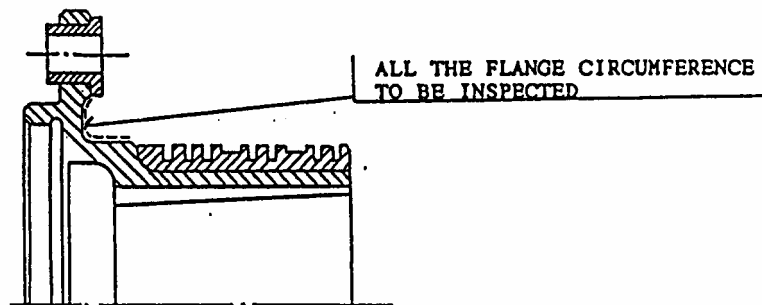
Reason: The oil distributor flange, distributor drawing No. P 7900-6111, applies for the V 500A propeller mounting on the M 337A or M 337AK engine. On some flanges, cracks were found during their inspection.

Action: Flange for the propeller mounting to be inspected. The flange outside surface from the reducing towards cylindrical portion to be checked all around the flange circumference, in the blade center line specifically (see Figure below), by using an appropriate detection method.

During inspection, special attention shall be given to the flange areas located in blade longitudinal axes. (In a hub. propeller blades are put to "O" markings on flange circumference).

The flanges having cracks shall be replaced.

Flange inspection shall be carried out immediately upon receiving the Bulletin, and subsequently every 500±10 flight hours since installing in flight operation.
