AVIA PROPELLER Ltd Beranových 65/666 199 00 Praha 9 Czech Republic	SERVICE ADVISORY SA-14	DOA No. EASA.21J.072
-----------------------------------------------------------------------------	-----------------------------------------	-------------------------

PROPELLER GOVERNOR P-W2() SERIES:
OBTAINING CLEARANCE BETWEEN BETA
FEEDBACK LEVER AND BETA SWITCH CAM

AVIA dual acting propellers installed on Walter M601 and GE H80 engines and controlled with AVIA P-W2() series governor.

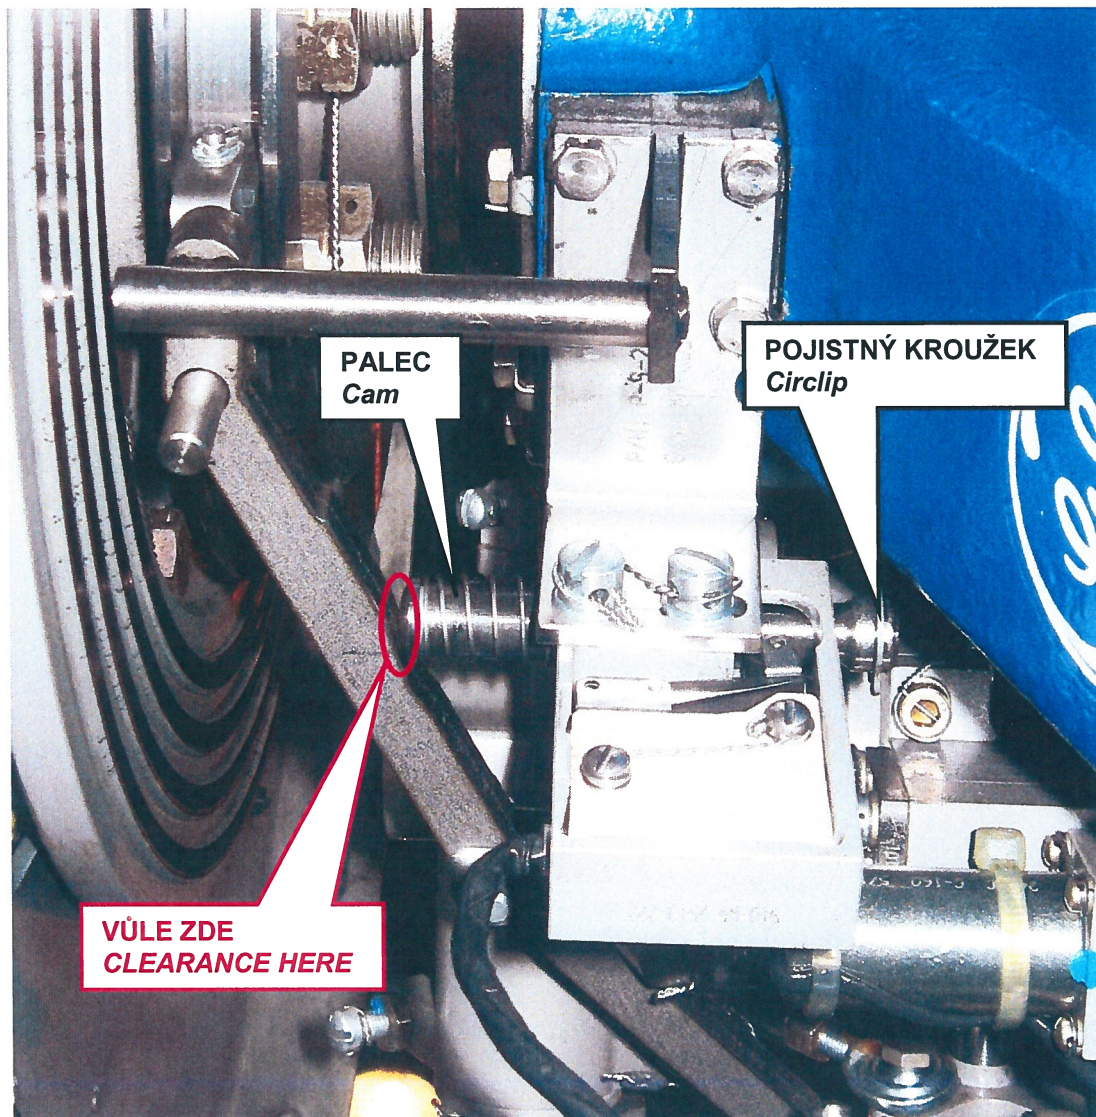
Elimination of push force of the cam to the beta feedback lever to prevent excessive wear of the beta block in the beta ring.

1. Make sure that propeller is in feathering position.
2. Remove circlip from the groove on the end of the cam.
3. Insert washer(s) of appropriate thickness and reinstall the circlip to establish the gap between the cam and the beta feedback lever. This gap should not be greater than 0,8 mm (0.032 inch).

4. Using 5 min. epoxy adhesive, bond the washers to each other and to the circlip.

THE WASHERS MUST NOT BE LOOSE ON THE CAM, OTHERWISE HANG-UP OF THE CAM MAY OCCUR.
