SUBJECT:

This document provides advice how to correct the position of the Beta switch assembly P-S-2 P/N:222-0168. It is applicable if cannot be reached correct setting of the Beta switch assembly.

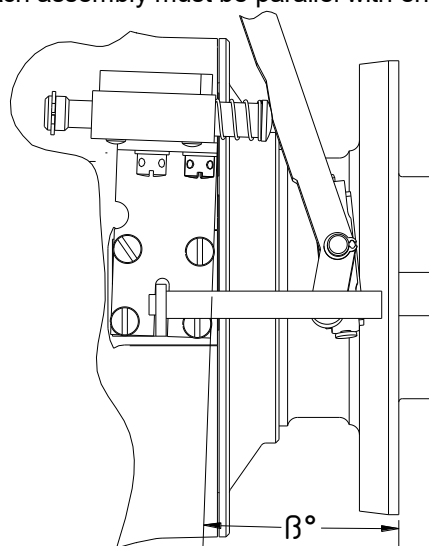
A. The reason for inability to reach correct setting of the beta switch assembly is wrong inclination of the beta switch assembly. Fig.1 shows beta switch assembly with wrong inclination (see angle β°). Proper mounted beta switch assembly is on Fig.2. Beta switch assembly must be parallel with engine flange (see Fig.2).

Fig.1 Beta switch assembly mounted with wrong inclination

B. Correction of wrong mounted beta switch assembly (see part III. paragraph A) is according following procedure: First remove locking wire from four screws which holds beta switch assembly and beta lever support on the engine gearbox. Then slightly loose the screws and adjust the inclination of the beta switch assembly. The bracket of the beta switch assembly must be parallel to the engine flange (move with beta switch assembly in the direction of the arrow = away from propeller) (see Fig.2).

C. Tight the screws of the bracket when the beta switch assembly and beta lever support is in proper position. Lock with lock wire.

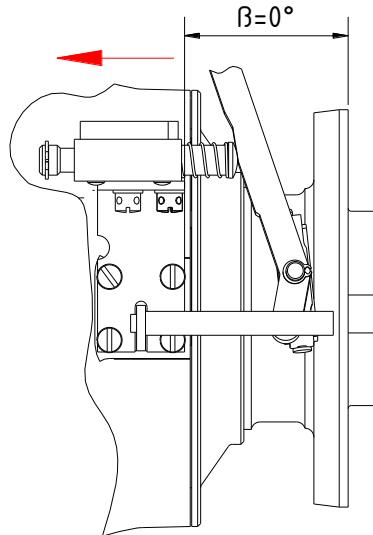
Fig.2 Beta switch assembly mounted with correct inclination
