Shortened conclusion of technical report No. 4300477 "Analysis of crack on propeller blade" by Department of strength at SVUM Běchovice, accredited testing laboratory No. 1151.

## **Summary of findings and conclusions**

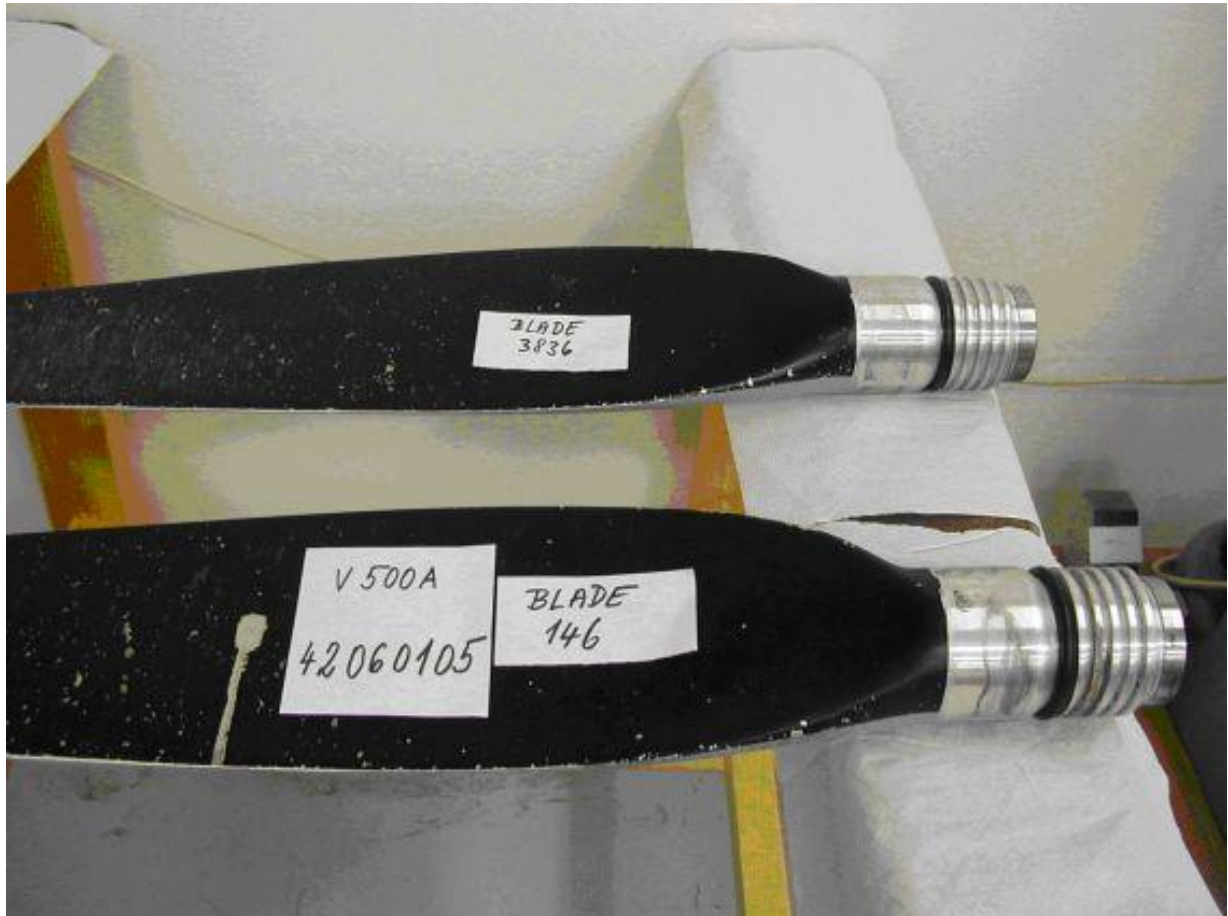
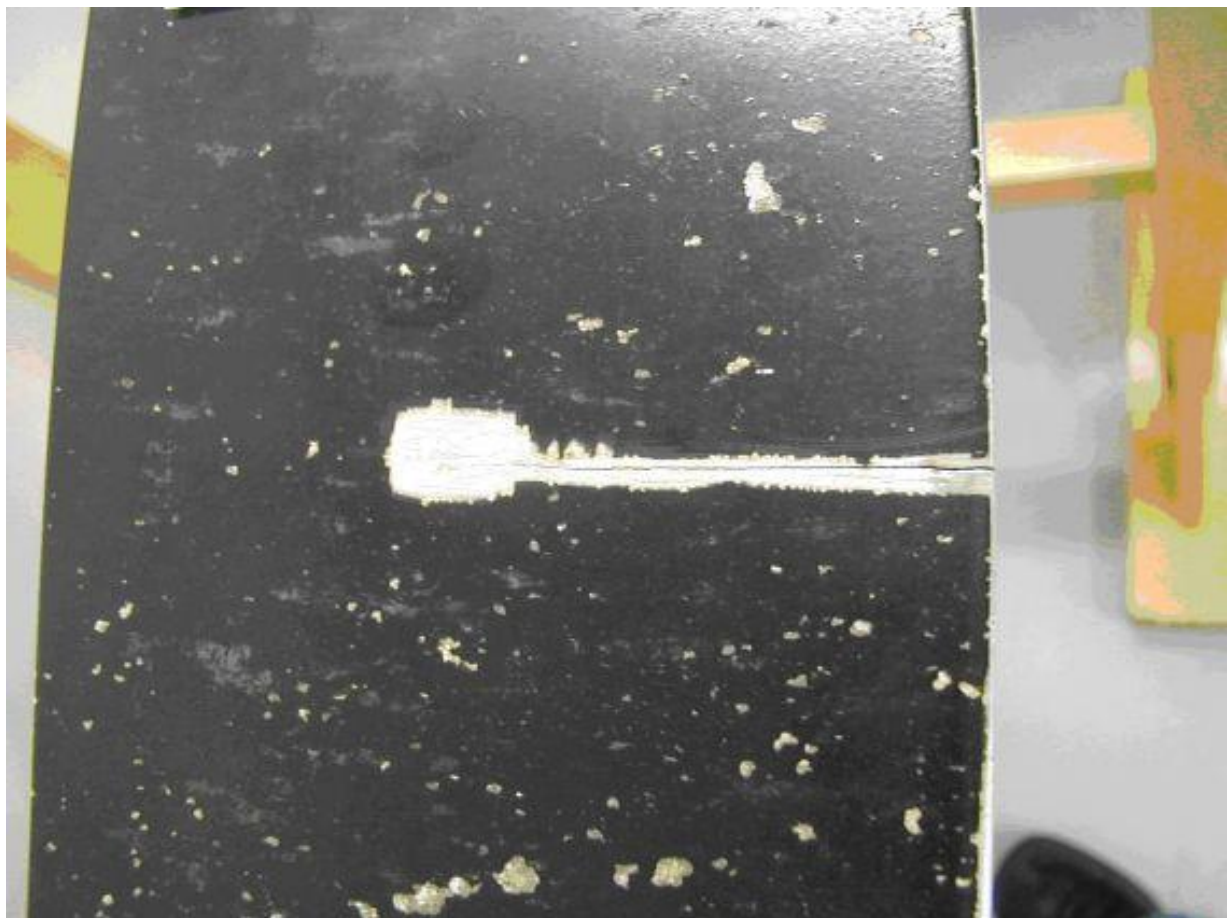
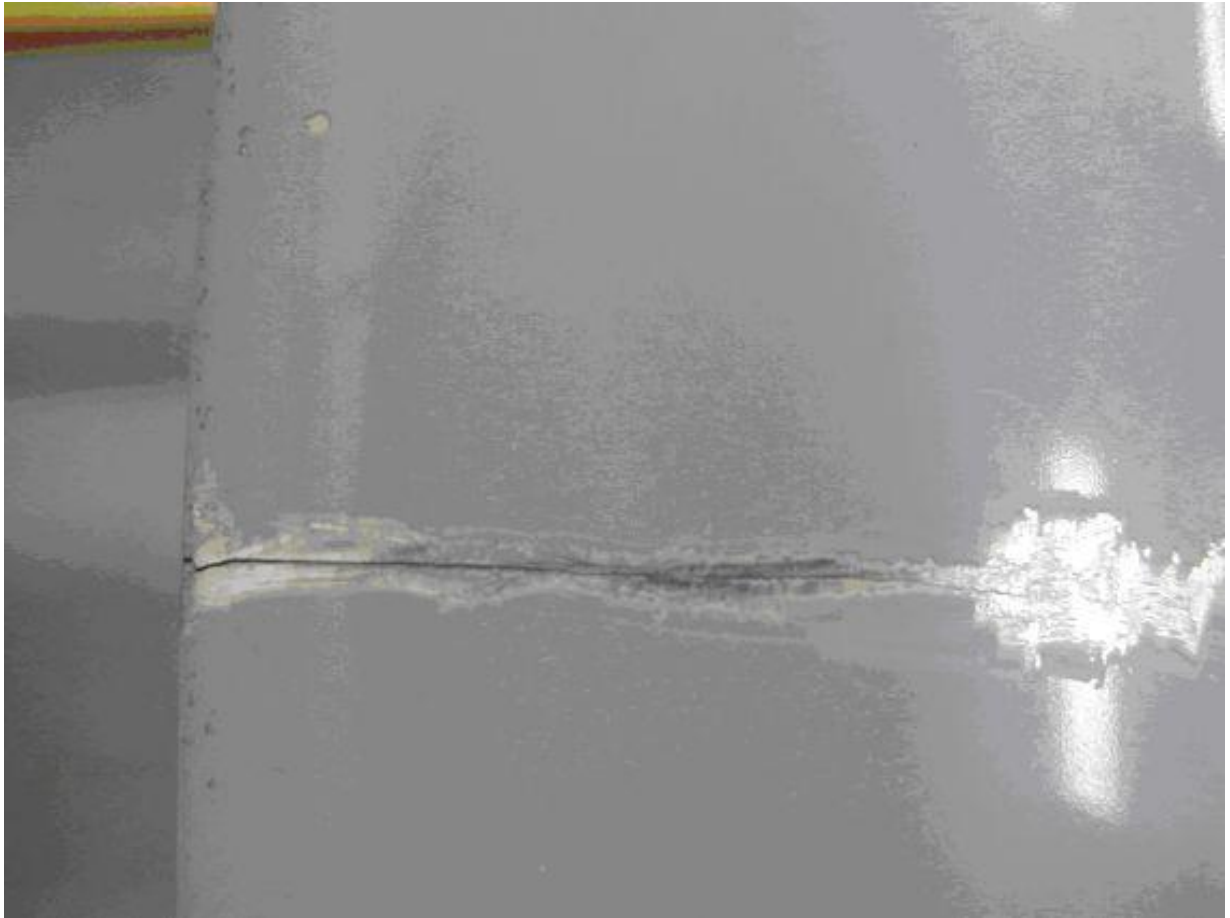
Pictures - Avia Propeller

According to investigation, the formation of fatigue crack on propeller blade refers to the repair method of the leading edge with welding. Welded area has rounded form of dimension about 25 x 9 mm.

The fatigue crack itself was developed from the defective area in the crack starting zone of dimension about 5 mm at leading edge.

Further crack with intercrystal course of the length about 6 mm goes parallel towards the fatigue crack plane in distance of about 4 mm. It confirms the point of view, that the cracks was developed in the area of welding because of internal stress and welding process itself. These cracks were main reason for starting of fatigue failure. Presence of these defects in high stress area of the propeller blade then led to developing of founded long fatigue crack.

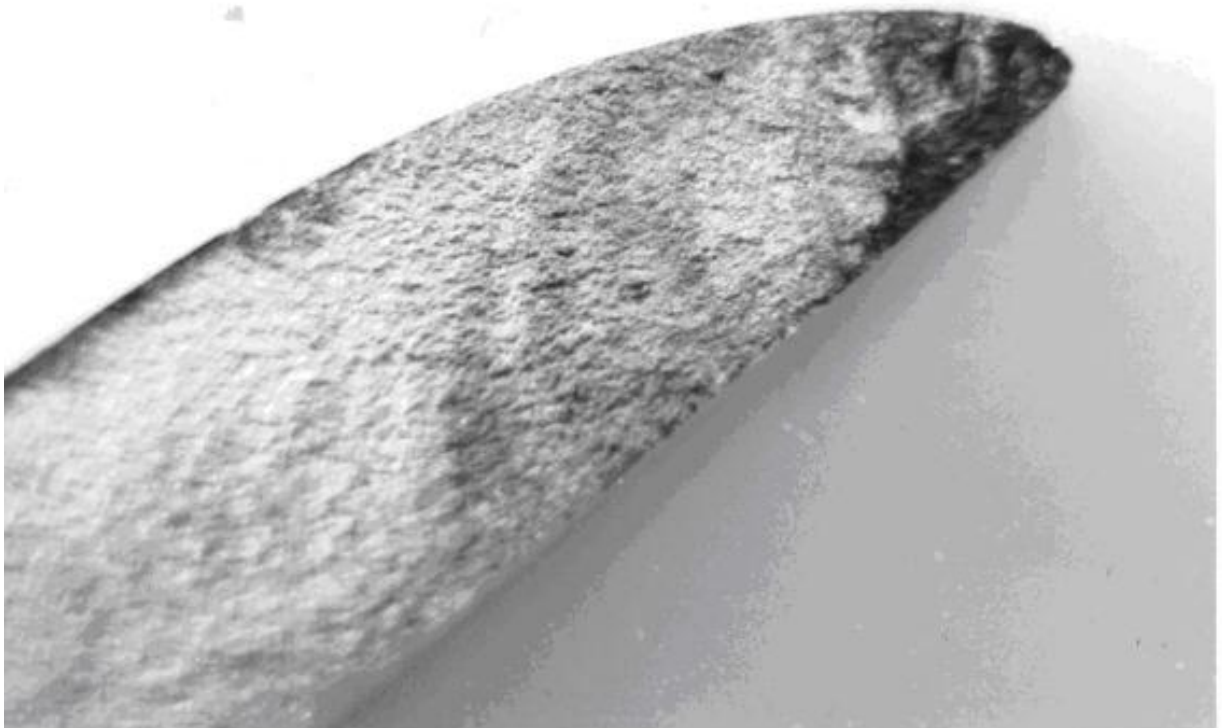
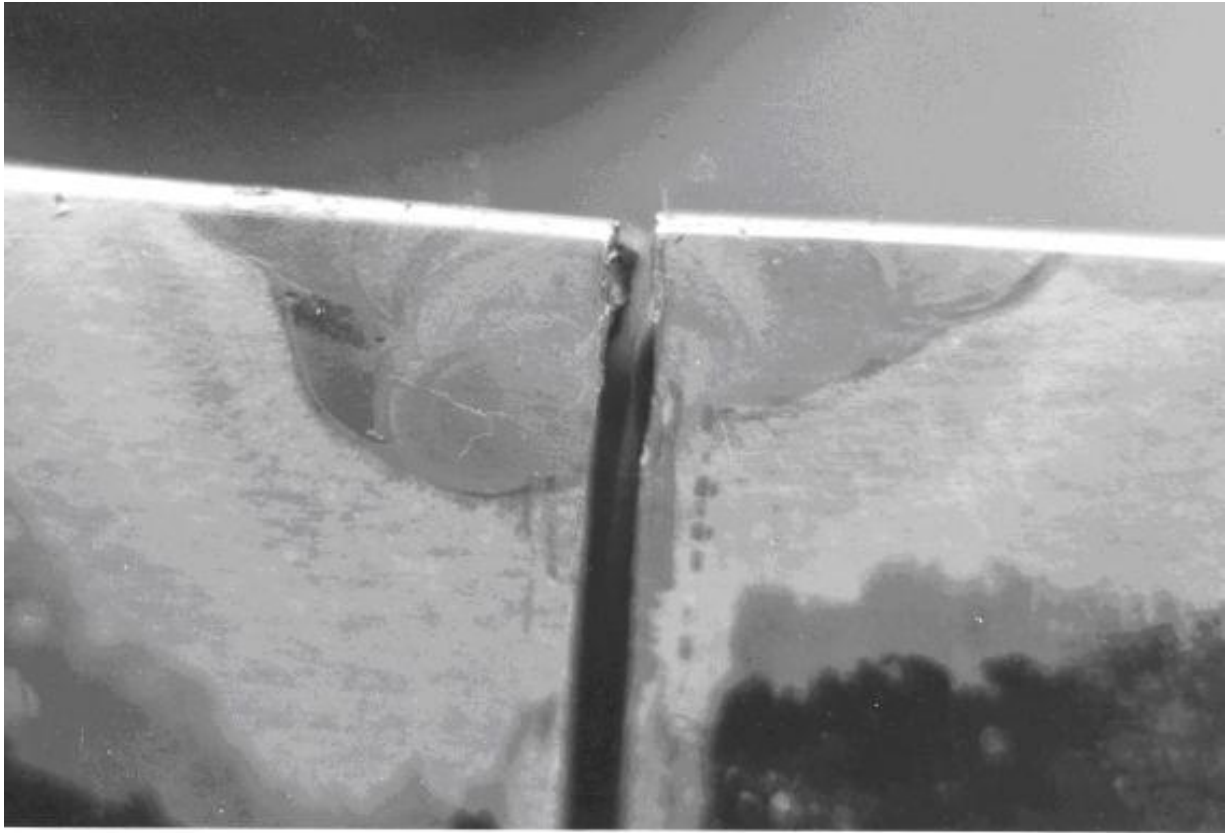
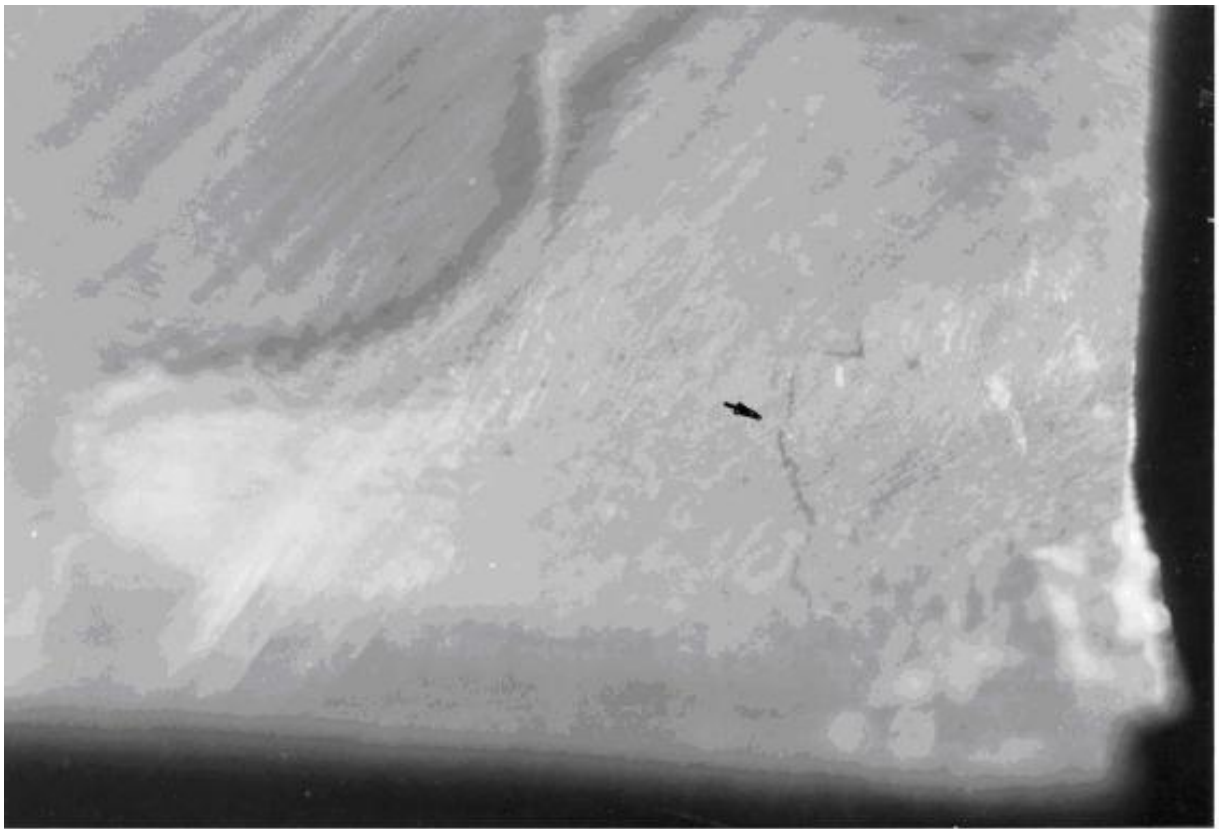
Pictures - SVÚM a.s. Běchovice

One of stairs in those defective starting zones of crack area is directly related to the crack, which is in the welded repaired area.

The fatigue crack itself has stair character of developing, which is evidently related to condition of variable load in operation and with repeated starts.
